21st Century Dam Design — Advances and Adaptations

31st Annual USSD Conference
San Diego, California, April 11-15, 2011

EVALUATING THE RISKS OF AN INTERNAL EROSION FAILURE AT AMISTAD DAM

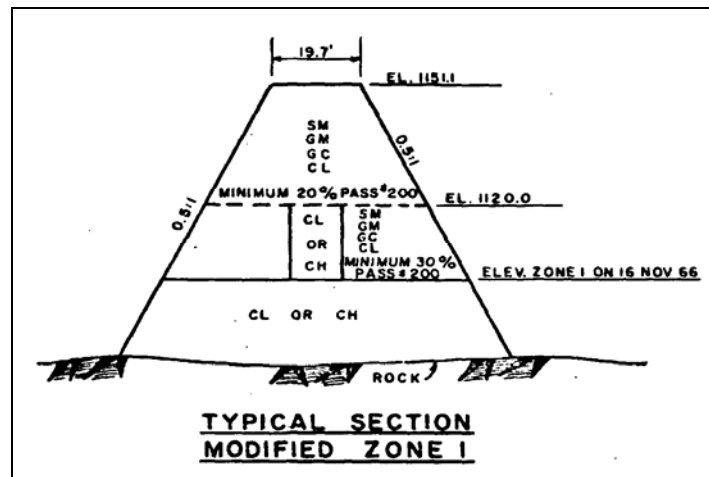
reported above, the average downstream zone 3 material does not satisfy Sherard and Dunnigan filter criteria for the average zone 1 core, suggesting that zone 1 material has the potential to migrate into zone 3 shell material.

Figure 2. Configuration of United States Side Zone 1 Core
Note: Dimensions shown in feet instead of meters

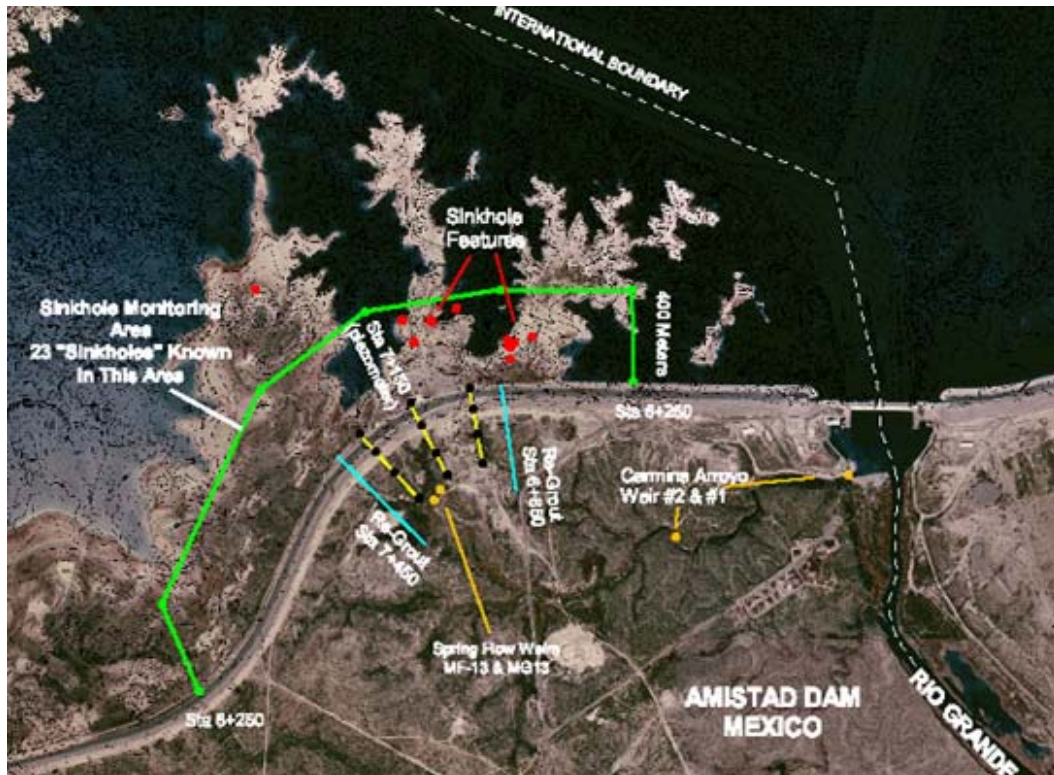
- A year after the observation of sand at Carmina, the reservoir pool had receded to near elevation 328 m, which is more than 12 m below the normal high pool level of elevation 340.5. The pool had been this low only once since initial filling. In October 1994, with the pool at this approximate low level, a sinkhole was observed in the reservoir area on the Mexico side. This feature was observed approximately 250 meters upstream of the upstream dam toe at dam station 7+100. Ten more sinkholes were observed in the same general area over the next three months. Two more sinkholes were then observed in June 1996 and an additional five in 1997. Most of these sinkholes were located between dam stations 6+500 and 7+200, and none of the reported sinkholes was closer than 200 meters from the upstream toe of the dam. The general location of these features is shown in Figure 3. During this period of sinkhole observations, the pool had remained at low levels and downstream seepage appeared to be at normal levels. A possible explanation for the occurrence of these features is that the sinkholes are at the location of ancient “paleo-chimneys” or collapse features which formed in geologic time and were

subsequently infilled. Upon reservoir impoundment, infilling materials within these collapse features became saturated. Once the reservoir was drawn down for a long period in the 1990's, effective stresses increased in the infilling material (buoyant weights went to total saturated weights), and the infilling material collapsed under its own weight. An alternate explanation would be that the sinkholes are manifestations of active internal erosion.

Figure 3. Location of Sinkholes on Mexico Side

- Dye tests were performed in the sinkhole area in the 1994-95 timeframe. In one reported application, dye was introduced into Sinkhole No. 1, and appeared in the Carmina seeps approximately 9 hours later. The distance traveled (in a straight line) was estimated at 400 m. The computed seepage velocity would be on the order of 0.01 m/s, which is quite low. In another test, dye was introduced in a drill/piezometer hole in the sinkhole area and arrived at Arroyo Jaboncillos approximately 22 hours later. That distance was estimated at 3.5 km, making that computed seepage velocity 0.04 m/s.

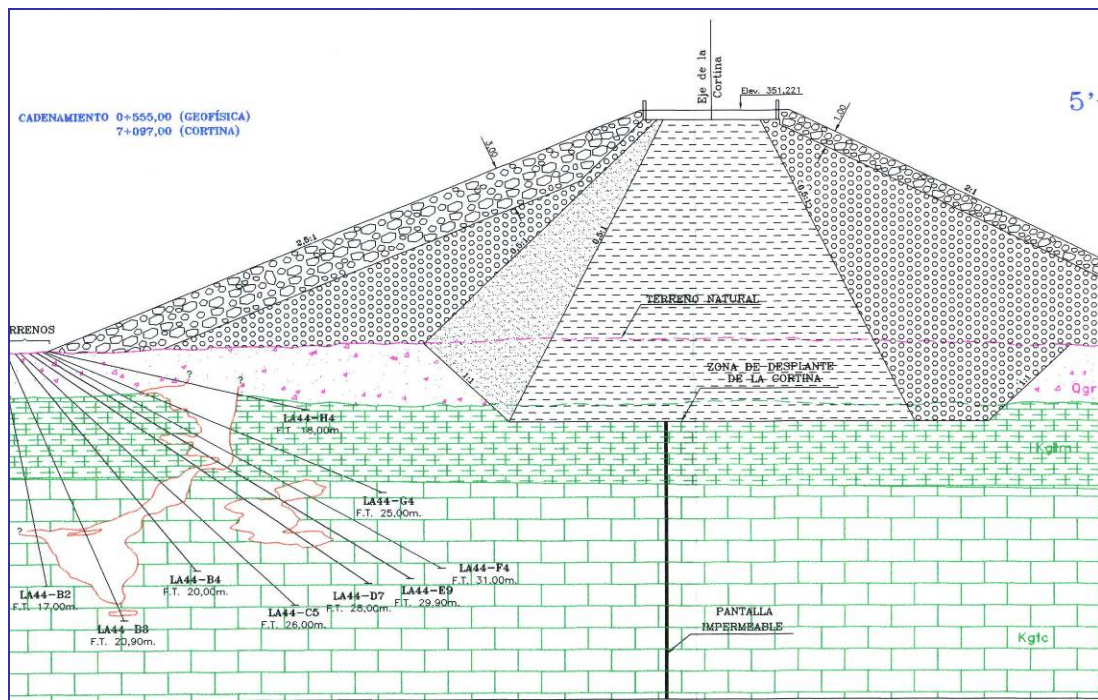
Figure 4. Sinkhole Grouting at Upstream Toe

- In August 1995, grouting was initiated in the area of the sinkholes, between dam stations 6+850 and 7+450. The grouting program essentially consisted of two components – re-grouting of the curtain along the dam axis, and grouting at the upstream toe of the dam. The intent of the grouting was to intercept potential seepage paths near the foundation contact, fill any voids that might have developed from the seepage pathways, and thus minimize the potential for internal erosion of foundation and embankment materials within the dam footprint. As shown on Figure 4, voids were encountered at some locations and likely filled with grout.

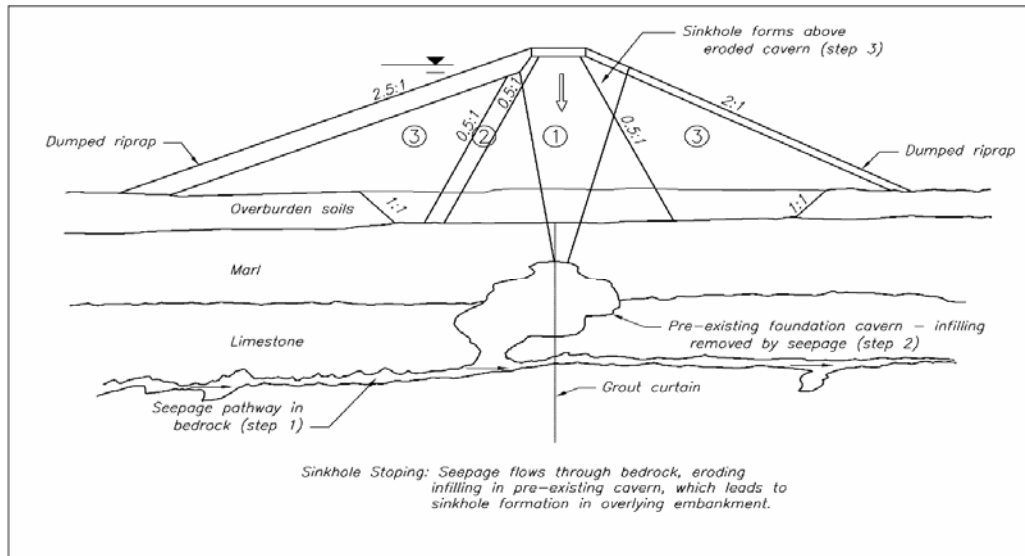
Seepage flows along a discontinuity in the marl or weathered limestone with sufficient velocity and capacity to erode materials from a pre-existing foundation cavern. Cavern begins to stoep or erode upward due to gravity or along an existing vertical discontinuity. Bedrock, overburden, and/or clay filling are removed until base of embankment is encountered.

- If sinkhole occurs at dam centerline, dam could breach by overtopping from crest loss or internal erosion due to cracking.
- If sinkhole occurs on upstream slope, dam could breach by flow from the reservoir through sinkhole.
- If sinkhole occurs on downstream slope, dam could fail from slope stability.

Figure 5. PFM1 - Sinkhole Stopping Failure Mode

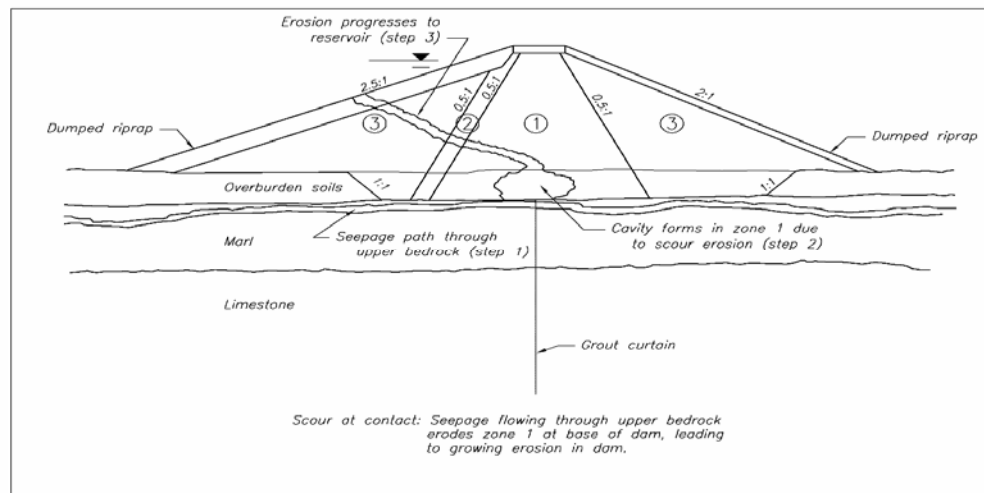
Concentrated seepage flows through the uppermost portion of the marl or weathered limestone. Seepage has sufficient velocity/capacity to begin erosion of unprotected embankment core at base of cutoff trench. As cutoff trench embankment material is removed, settlement and transverse cracking occurs in dam embankment. Internal erosion continues to progress through damaged/cracked core material ultimately leading to dam breach by erosion. A sketch of this potential failure mode is included as Figure 6.

Figure 6. PFM2 - Scour at Contact Failure Mode

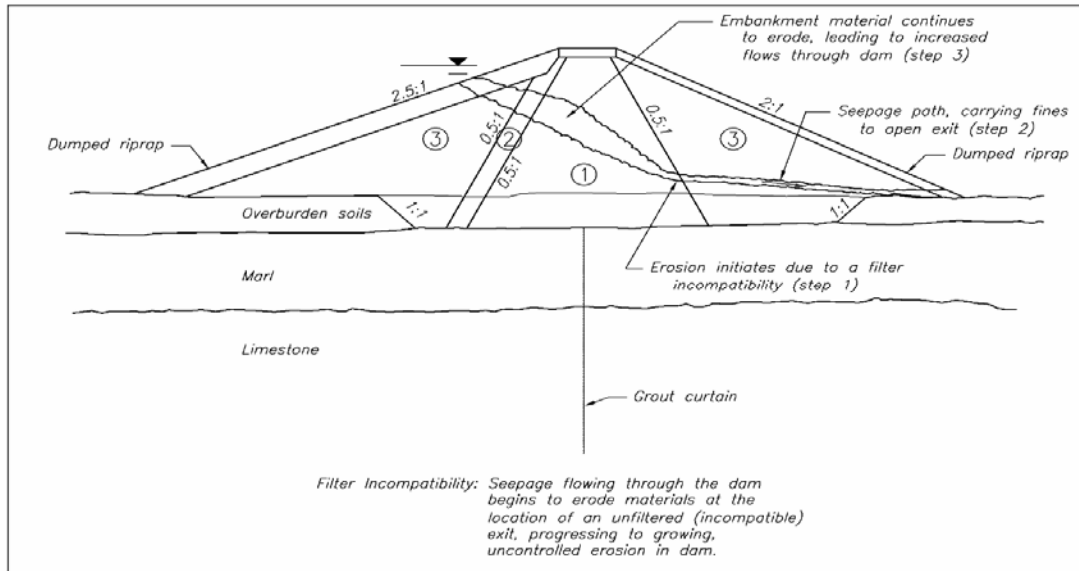
Concentrated seepage, or seepage under sufficiently high gradients, flows through embankment and encounters downstream embankment or foundation material that allows

an unfiltered exit. Erosion of core material begins at unfiltered exit. Backwards erosion piping leads to core material being transported through coarser downstream zones. Internal erosion progresses, which leads to dam failure by uncontrolled erosion or progressive slope failure. A sketch of this potential failure mode is included as Figure 7.

Figure 7. PFM3 - Filter Incompatibility Failure Mode

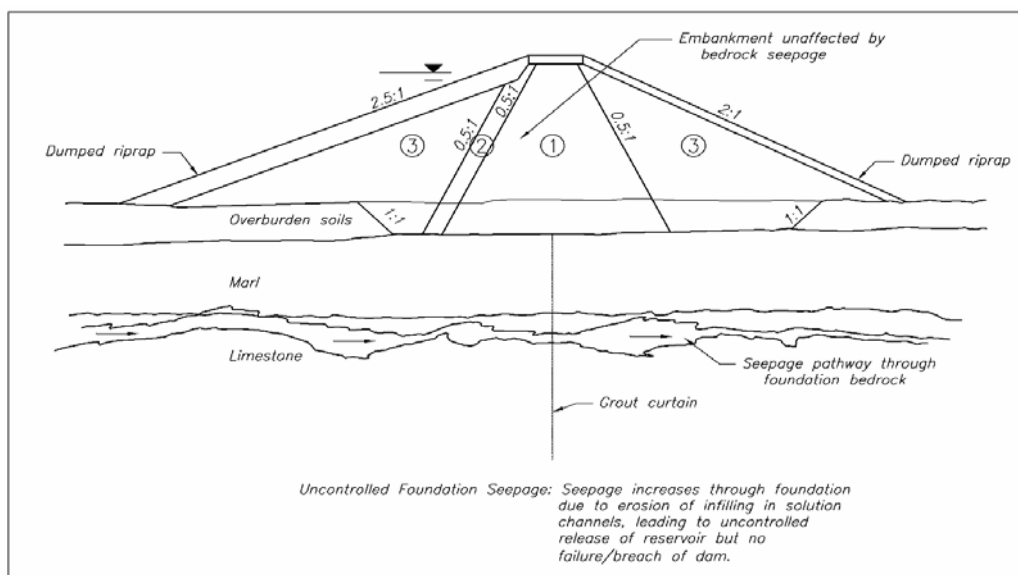
Seepage develops or enlarges in the foundation due to erosion or unplugging of clay infilling in existing discontinuity/flow path or network. Seepage continues to increase, leading to uncontrolled release of reservoir (no failure of embankment). A sketch of this potential failure mode is included as Figure 8.

Figure 8 – PFM4 - Uncontrolled Foundation Seepage Failure Mode

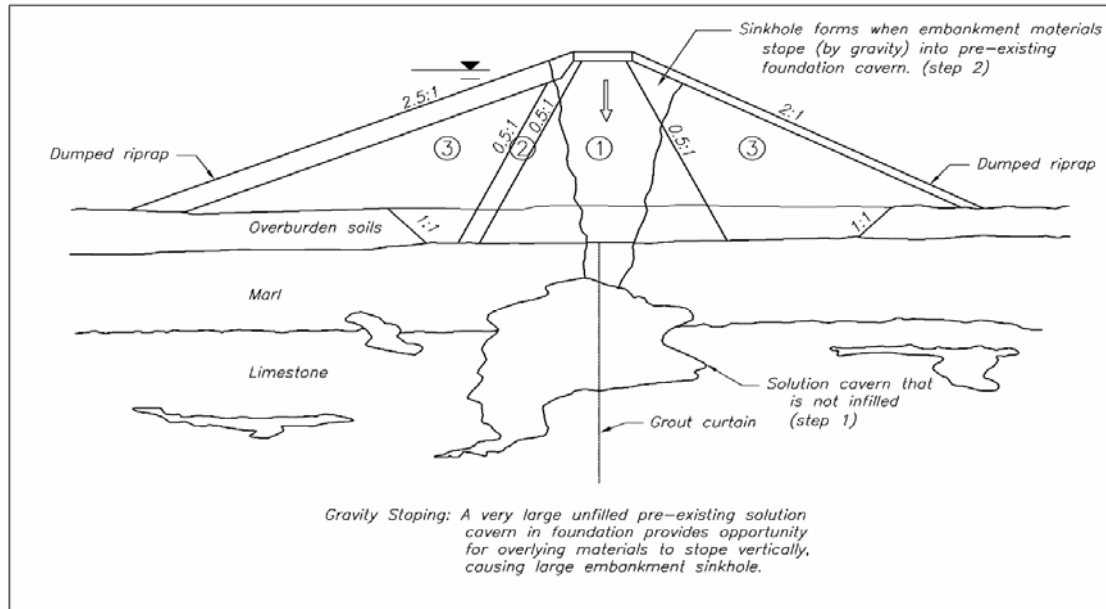
There exists beneath the embankment a large and unfilled solution cavity or one in which cavity infilling has been gradually removed by seepage that was not encountered or remediated during construction. Through gravity, bedrock and overburden slope into the cavity up to base of embankment. Stopping continues upward in embankment materials. If sinkhole occurs on dam centerline, the dam could breach by overtopping due to crest loss. If sinkholes occur on the upstream or downstream slopes, slope failure might occur. A sketch of this potential failure mode is included as Figure 9.

Figure 9. PFM5 - Gravity Stopping Failure Mode

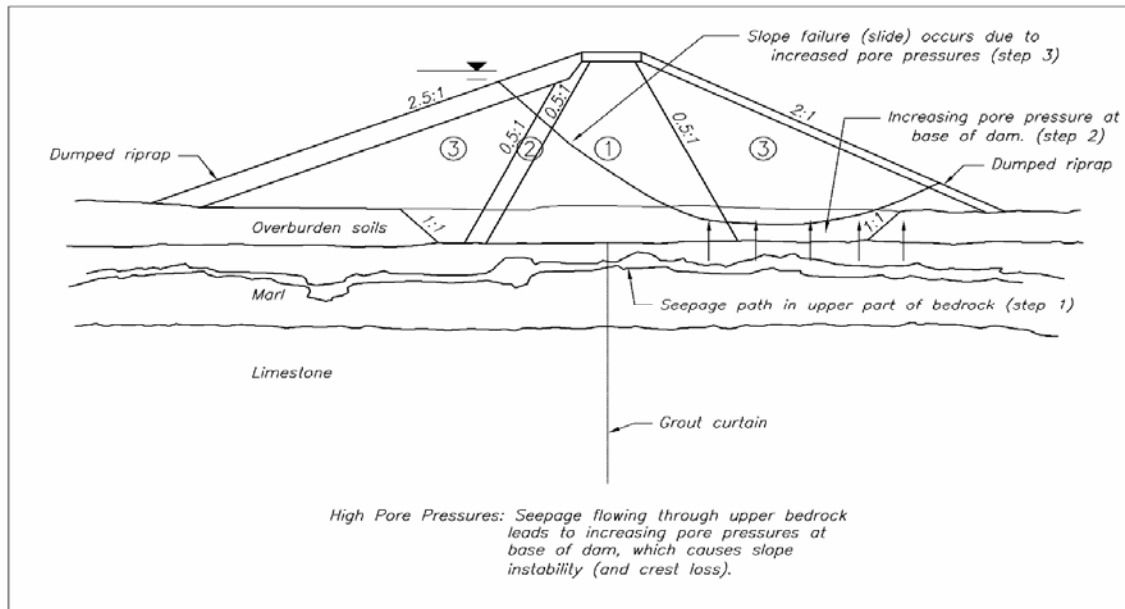
Water flow through an existing discontinuity in the upper portion of the marl or limestone undergoes a change such that pore pressures increase. This could be due to pathway enlargement and less head or plugging/unplugging along discontinuity. These high pore pressures are transmitted to the embankment materials resulting in lowered effective stress, reduced strength, and slope instability. Slope failure creates potential for large crest loss and dam breach. A sketch of this potential failure mode is included as Figure 10.

Figure 10. PFM6 - High Pore Pressures Failure Mode

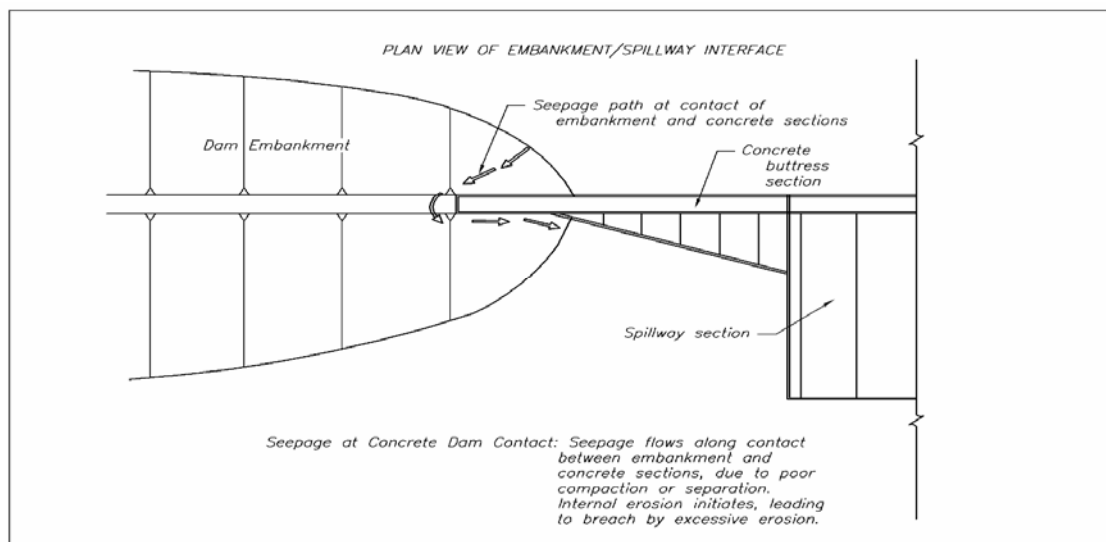
Concentrated seepage flows along the interface of the embankment and concrete dam structures, possibly due to poor compaction in the area of separation of embankment soils from the concrete. Core materials are eroded along this pathway through unfiltered shell materials. Erosion pathway continues to enlarge, leading to dam breach by excessive erosion or slope failure. A sketch of this potential failure mode is included as Figure 11.

Figure 11. PFM7 - Seepage at Concrete Dam Contact Failure Mode
